TEST REPORT No. 14/06A (2025)

REFERENCE: The Building Agency Limited,
1/14 Link Drive,
Wairau Valley.

Performance tests on The Building Agency composite Aluminium
cladding system in accordance AS/NZS 4284: 2008 Testing of Building
Facades.

DATE OF TEST: 14 - 16 July 2014

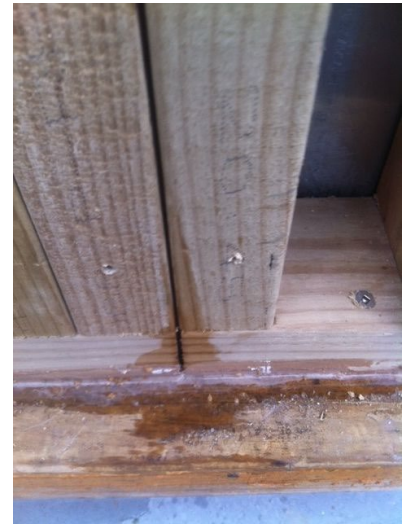
During the preliminary static water penetration test, water penetrated through open joints in the framing bottom plate, due to a leakage path through the bolt holes in the bottom timber portal plate of the test enclosure. This allowed water to penetrate to the underside of the framing bottom plate, tracking along to the open joints of the test framing bottom plate. The client applied sealing tape to the re-entrant corner between the test enclosure steel base and the portal plate to eliminate the leakage, as shown on Drawing “M”.

During the preliminary test the sample demonstrated “no water penetration” at a test pressure of 450 Pa, but at a pressure of 750 Pa water penetrated through two gaps in the sectional bottom plate due to a leakage path through the bolt holes in the bottom timber portal plate of the test enclosure. This allowed water to penetrate to the underside of the framing bottom plate, tracking along to the open joints of the test framing bottom plate.

The issue at the bottom plate was found to be that the portal plate is not fully sealed to the steel structure allowing air/water to track between the portal plate and the steel, penetrate through the bolt holes to the underside of the bottom plate. From there the air/water found a route under the bottom plate to the cut in the bottom plate and through any other imperfections along the portal plate causing the leak. As the root cause of this leak is not associated with The Building Agency's panel system, no panels were removed or altered. A remedy was effected by applying flashing tape to the underside of the portal plate and down onto the structural steel.
