## TEST REPORT No. 14/06B (2025)

**REFERENCE:** The Building Agency Limited,  
1/14 Link Drive,  
Wairau Valley.

Performance tests on The Building Agency composite Aluminium  
cladding system in accordance New Zealand Building Code E2/VM1:

**DATE OF TEST:** 18 - 19 July 2014

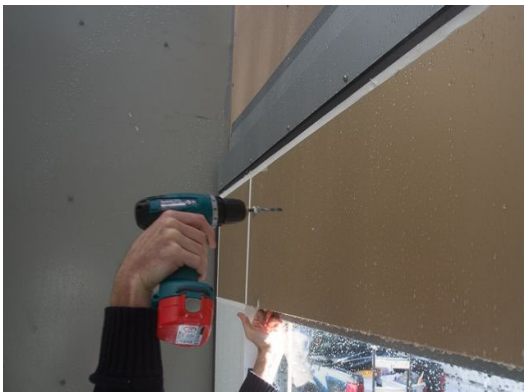
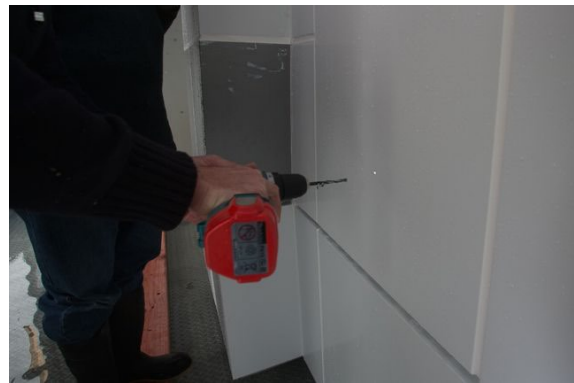
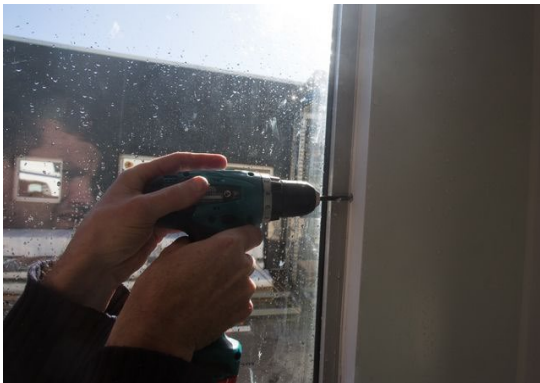
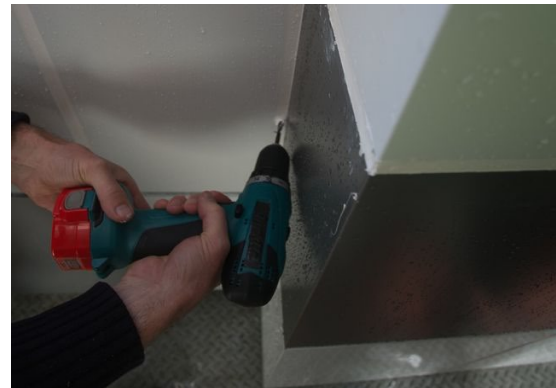
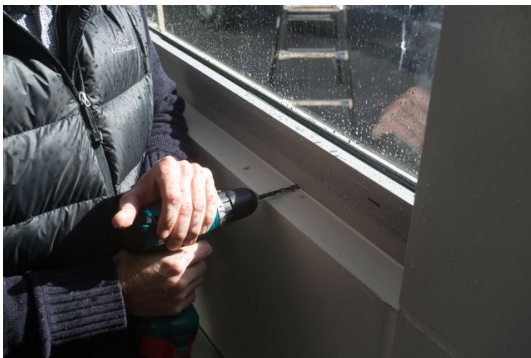
The following photos show the locations of the specified 6 mm diameter holes drilled for the Water Management test.

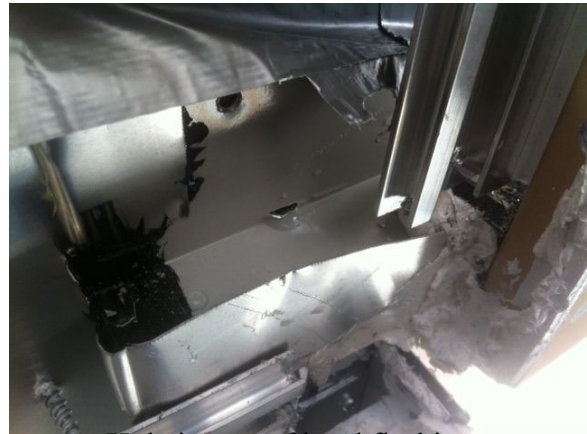
As the results below indicate, water penetration onto the plane of the building wrap was visible during the Series 3: Wet Wall Test Static Water penetration test. The clients subsequently removed the adjacent external panel and located a hole in the back corner of the head flashing that was allowing water to flow into the rear of the cavity, onto the plane of the building wrap. It was apparent that the head flashing damage had occurred following repairs to the window sill installation after water penetration occurred during the AS/NZS 4284 preliminary tests.

Hole in rear of head flashing

Following the repair to the damaged head flashing, no further water  
penetration occurred associated with the window head flashing.

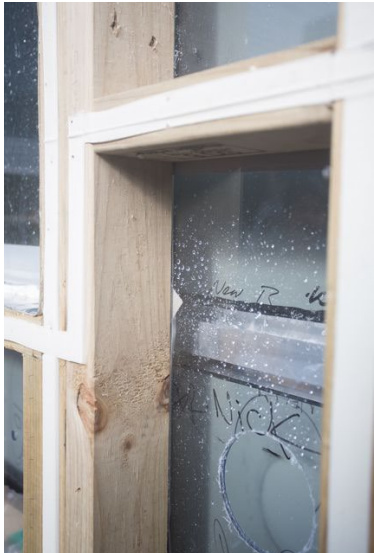
| <p>Series 3: Wet Wall Test Static Water penetration<br/>Test pressure 50 Pa<br/>Duration 15 mins</p> | <p>Water penetration around window head flashing, crossing cavity onto plane of building wrap. No other water transfer to plane of building wrap</p> | |

**Retest following repair to window head flashing**

| <p>Series 3: Wet Wall Test Static<br/>Water penetration<br/>Test pressure 50 Pa<br/>Duration 15 mins</p> | <p>No water penetration around window head flashing, No water transfer to plane of building wrap</p> |
