BRANZ FIRE TEST REPORT

FF12829-001

**BS 8414-2:2015+A1:2017 TEST OF ALUCOLUX FAÇADE SYSTEM IN
ACCORDANCE WITH BR 135 ANNEX B**

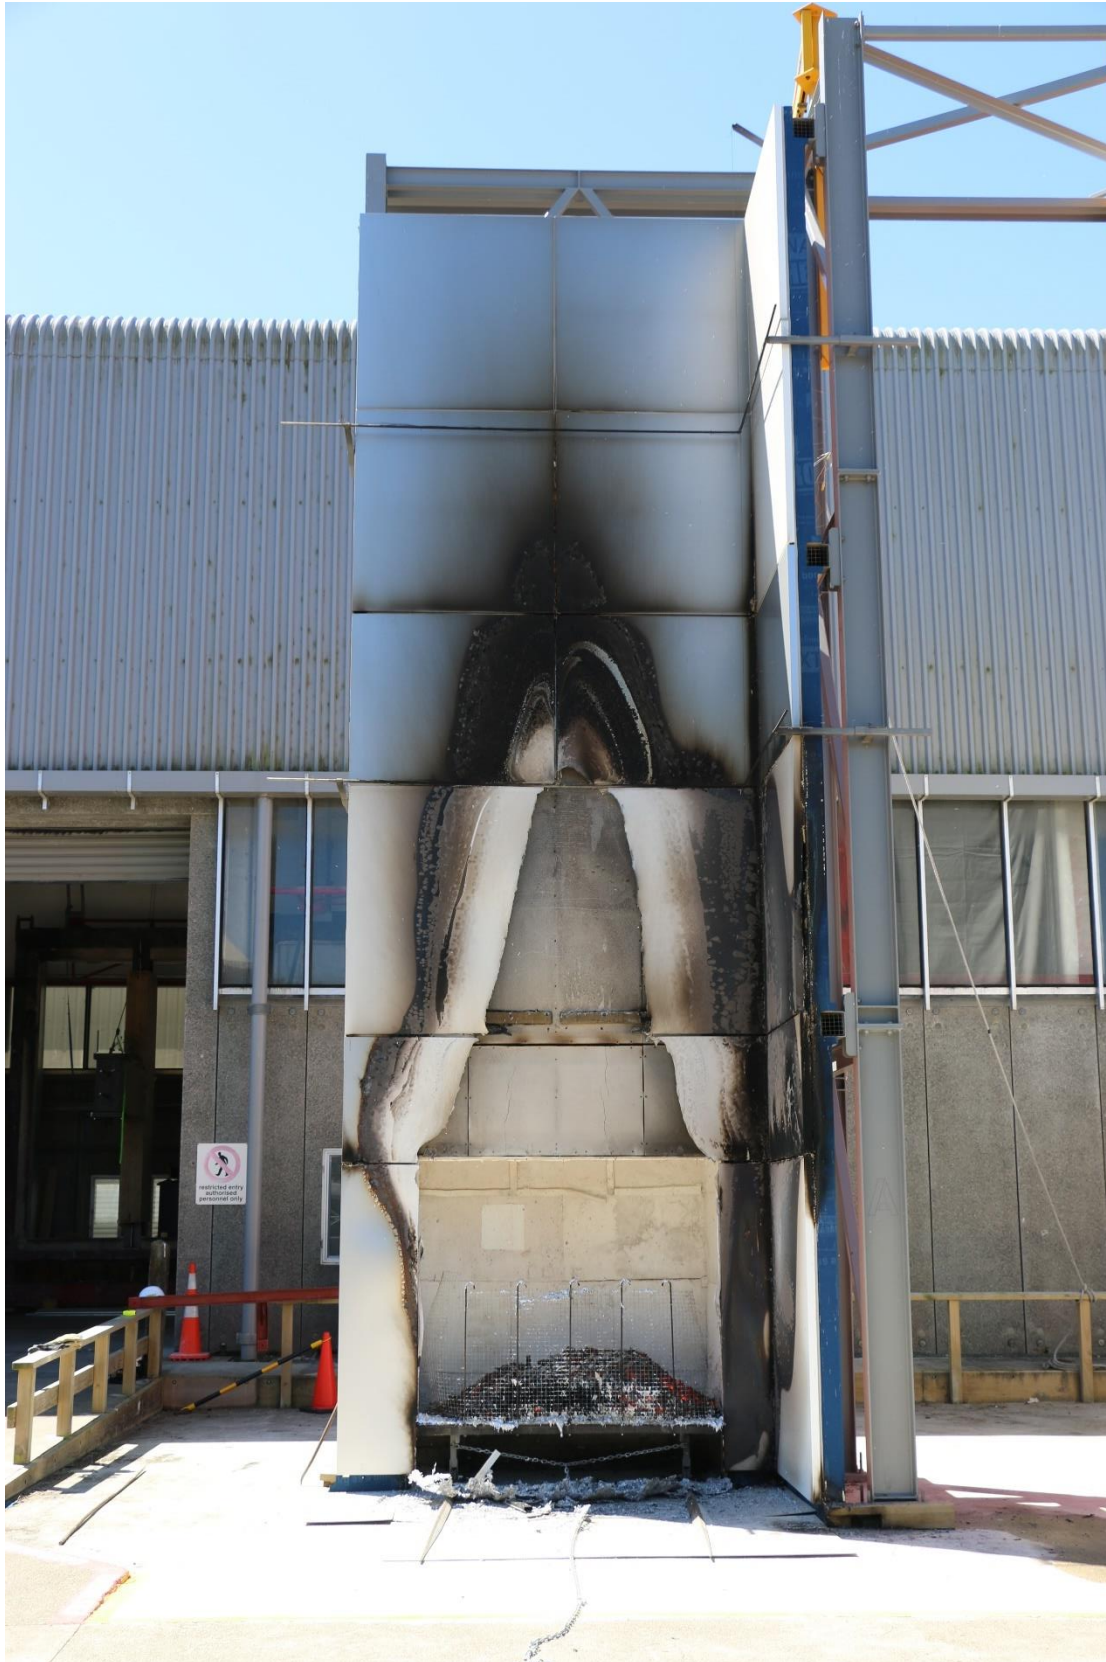
Photo 45: Post-test main wall

Gap sealant and PEF backing rod within the panel-to-panel junctions burned vertically up the centre of the combustion chamber opening to 5 m in height (Level 2) and along horizontal junctions from left side of specimen to wing wall junction, up to 2.5 m above the chamber opening.

The rigid air barrier cracked in two vertical fissures 600 mm above the combustion chamber opening nominally 300 mm each side of the main wall centre junction.

The timber framing encapsulating the floor slab beam nominally 600 mm above the combustion chamber was affected by burn-through nominally 100 mm high by 1.8 m in length, centrally located on the main wall of the test specimen. The left-side timber jamb of the combustion chamber opening burned away nominally 500 mm below the lintel. After-glow, smouldering, and reignition was observed up to 24 hrs after the test ended.

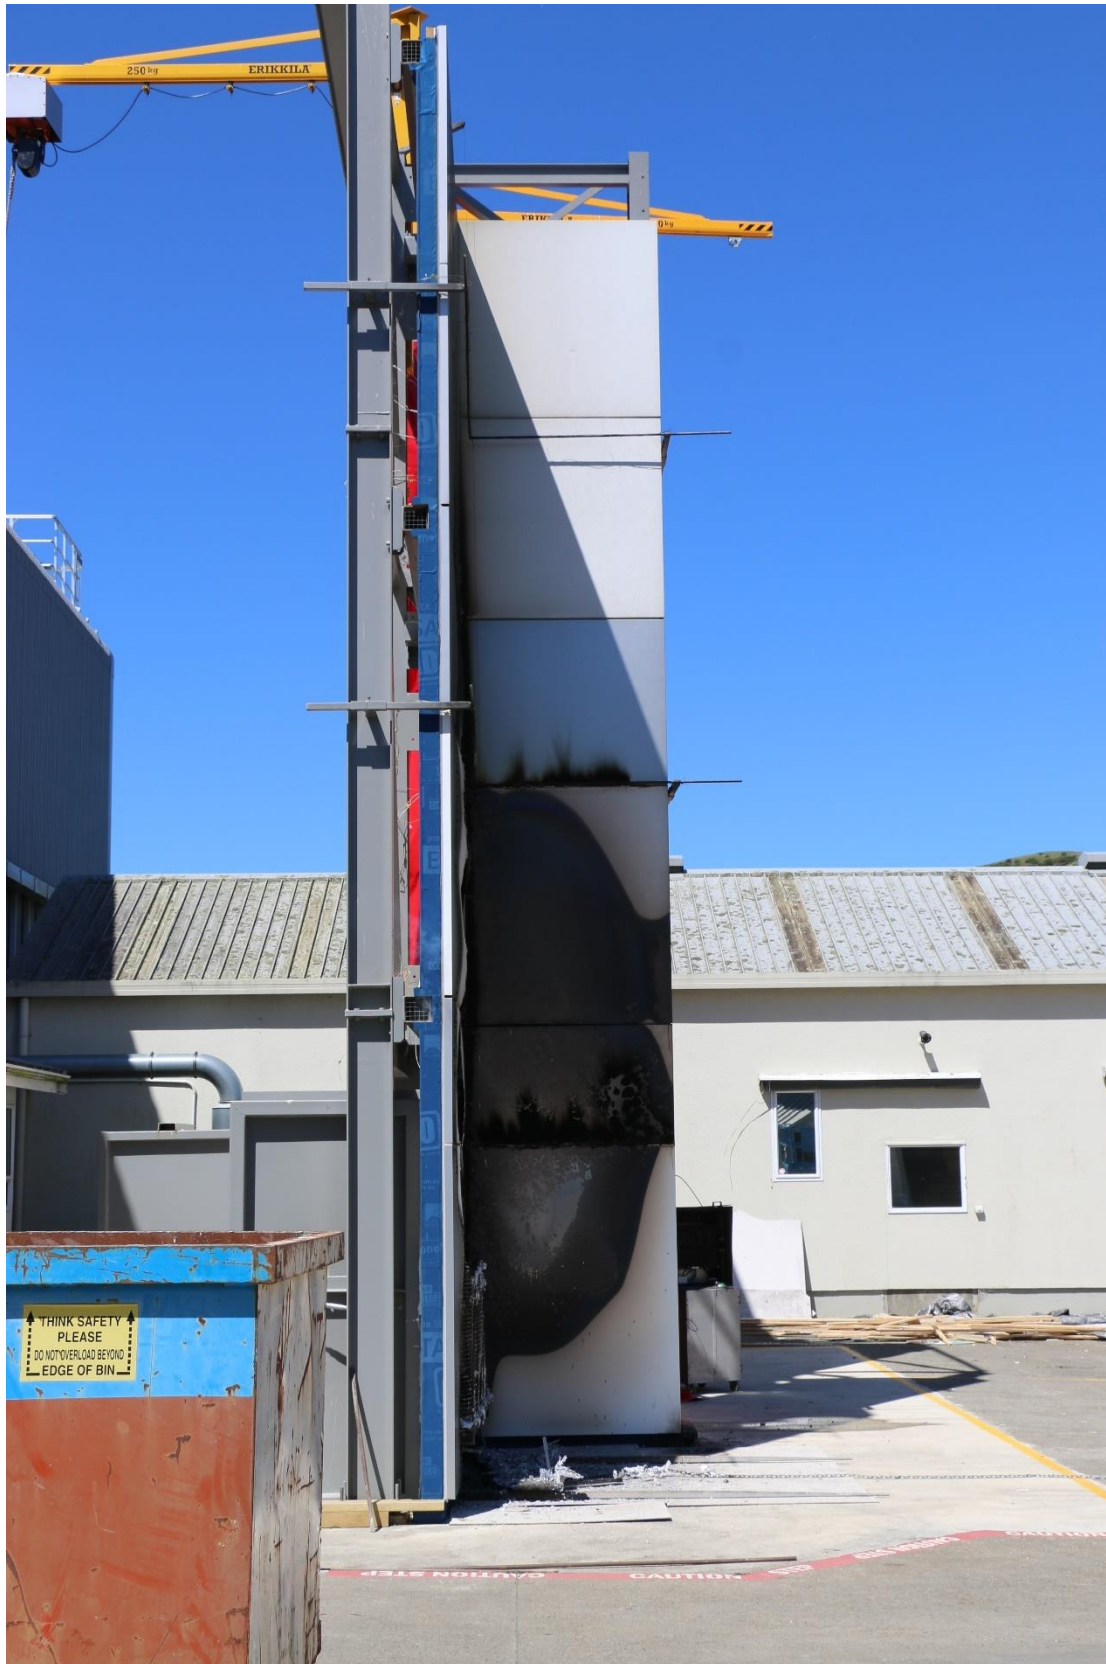
Photo 46: Post-test wing wall

18:00	There was flame spread up the outer vertical edge of the wing wall.
30:00	The crib trolley was extracted from chamber.
60:00	End of test.

Gap sealant with PEF backing rod in panel-to-panel rebates up to 2.5 m above the combustion chamber opening burned horizontally from main wall corner junction to the right-side edge of the test specimen. Sealant in the outer right side edge junction burned vertically to 2.5 m above combustion chamber opening (Level 1).

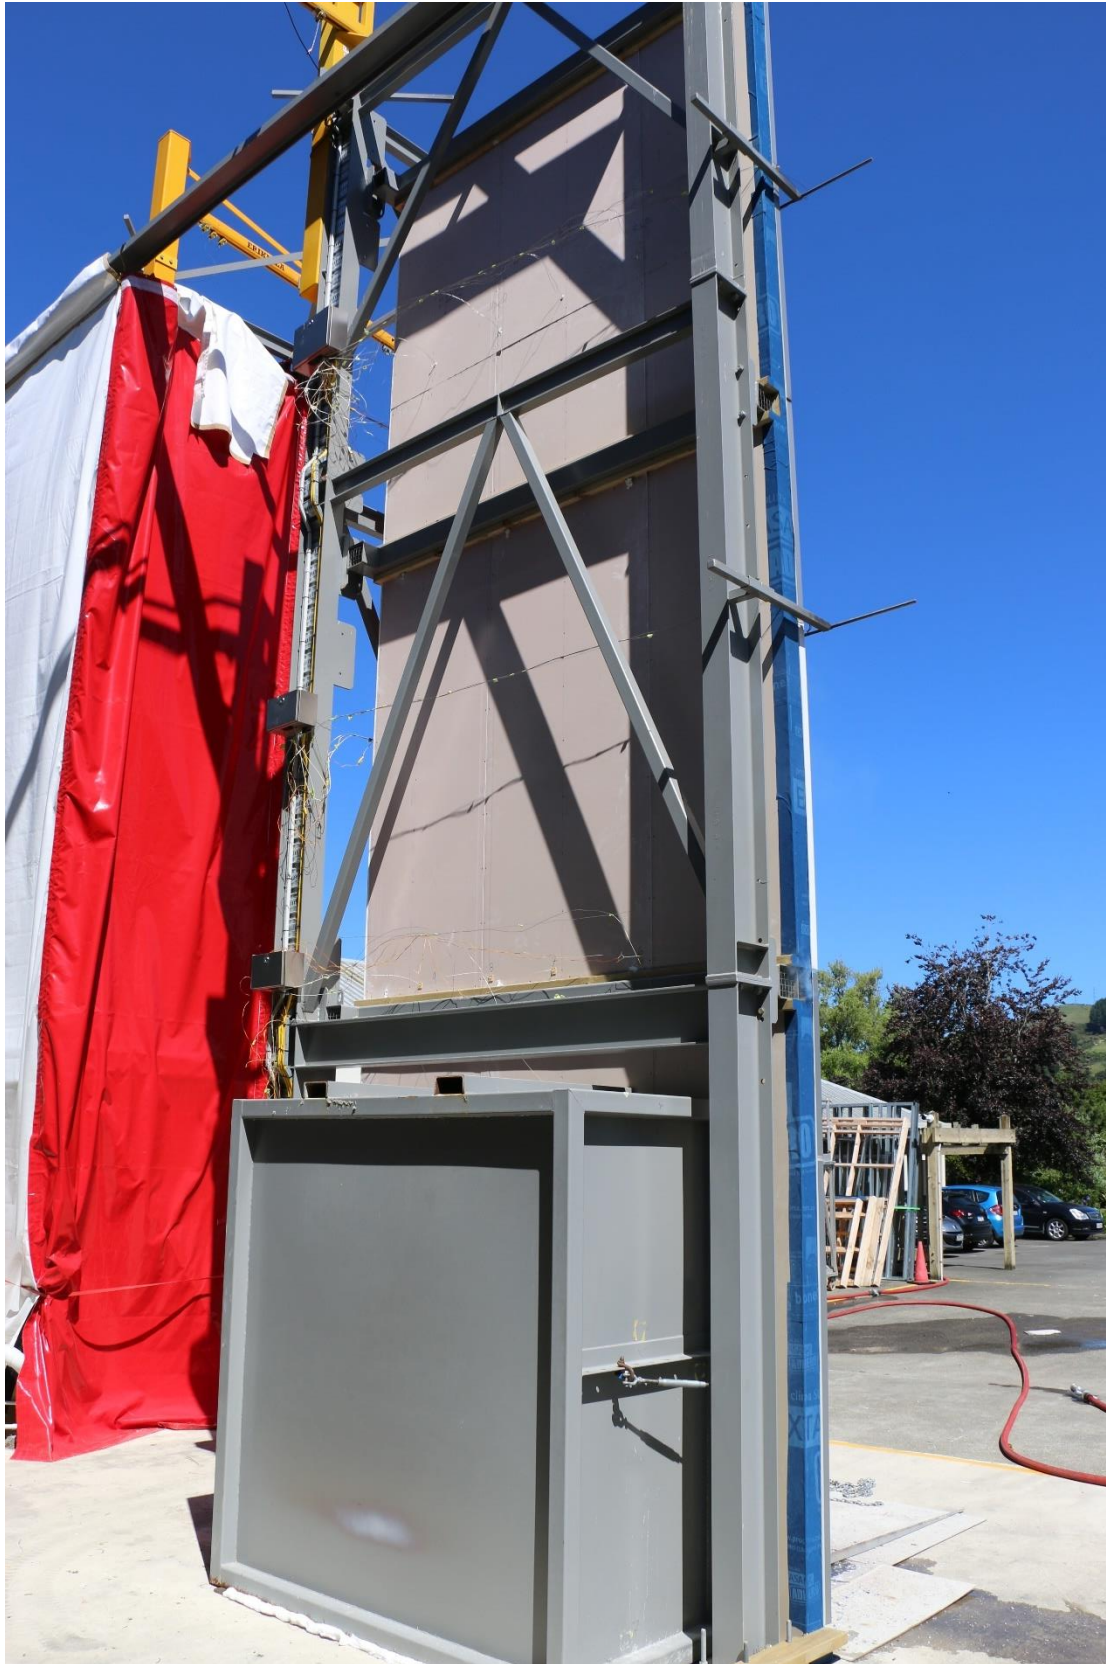
Photo 47: Post-test unexposed main wall

The internal plasterboard lining showed no signs of flame or smoke damage.
