Test Report 20-10

Testing of Frontek tile system in accordance with AS/NZS 4284:2008 'Testing of Building Facades'

Project:	Frontek tiles on aluminium rails
Client:	The Building Agency
Specifier:	Lautrec
Sample designer:	Symonite NZ Ltd
Installer:	Symonite NZ Ltd
Test dates:	21 - 24 Aug 2020 (and 4-8 Aug for SLS deflections on studs)

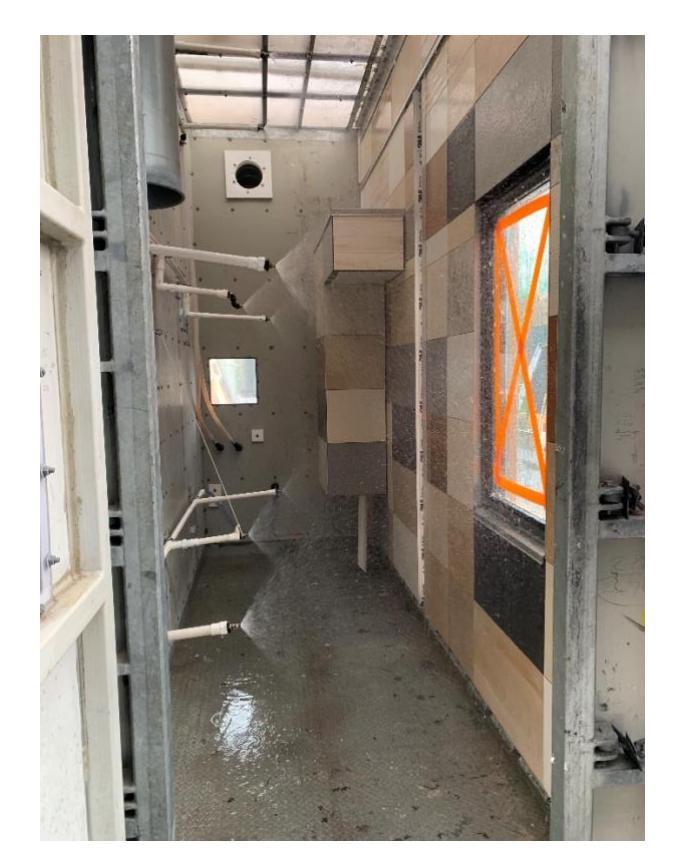
Figure 1: View of wet-side of sample face, showing selection of exterior tiles

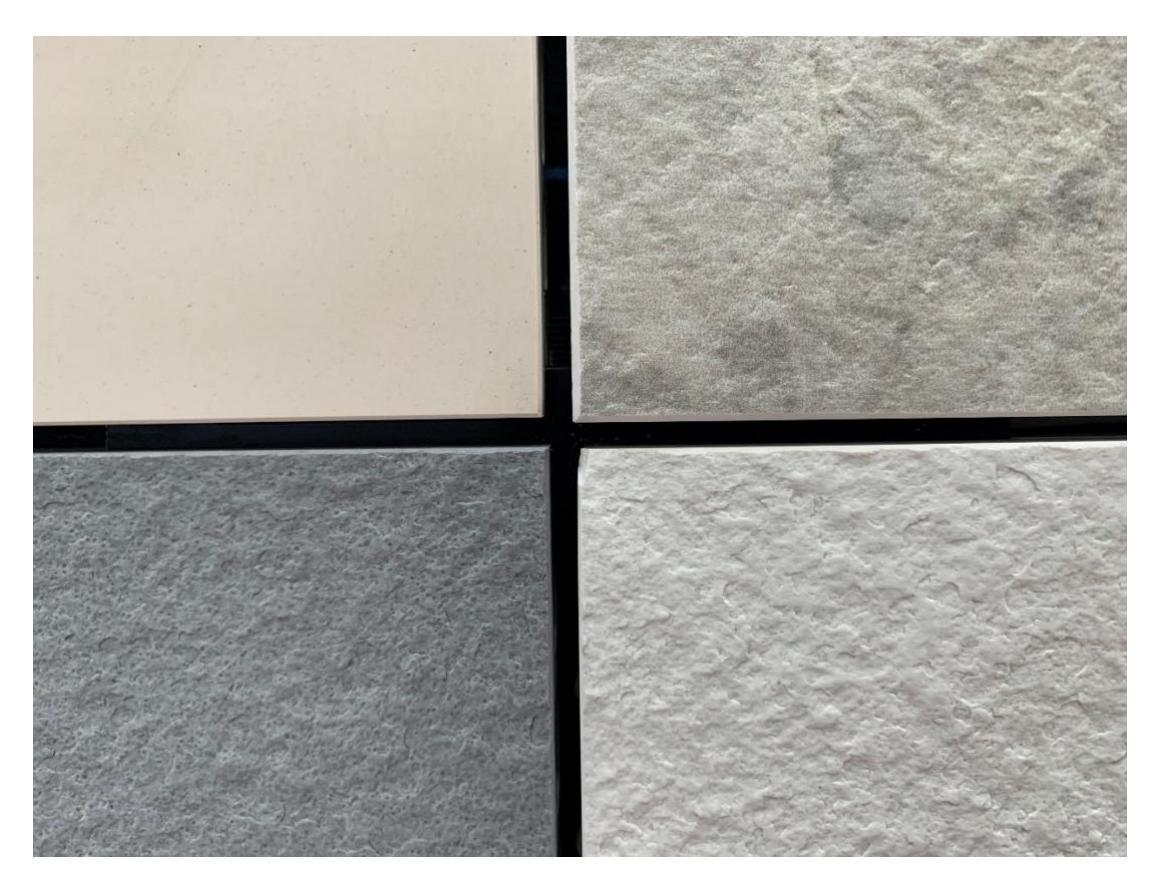
Figure 2: Cladding tiles cruciform joint

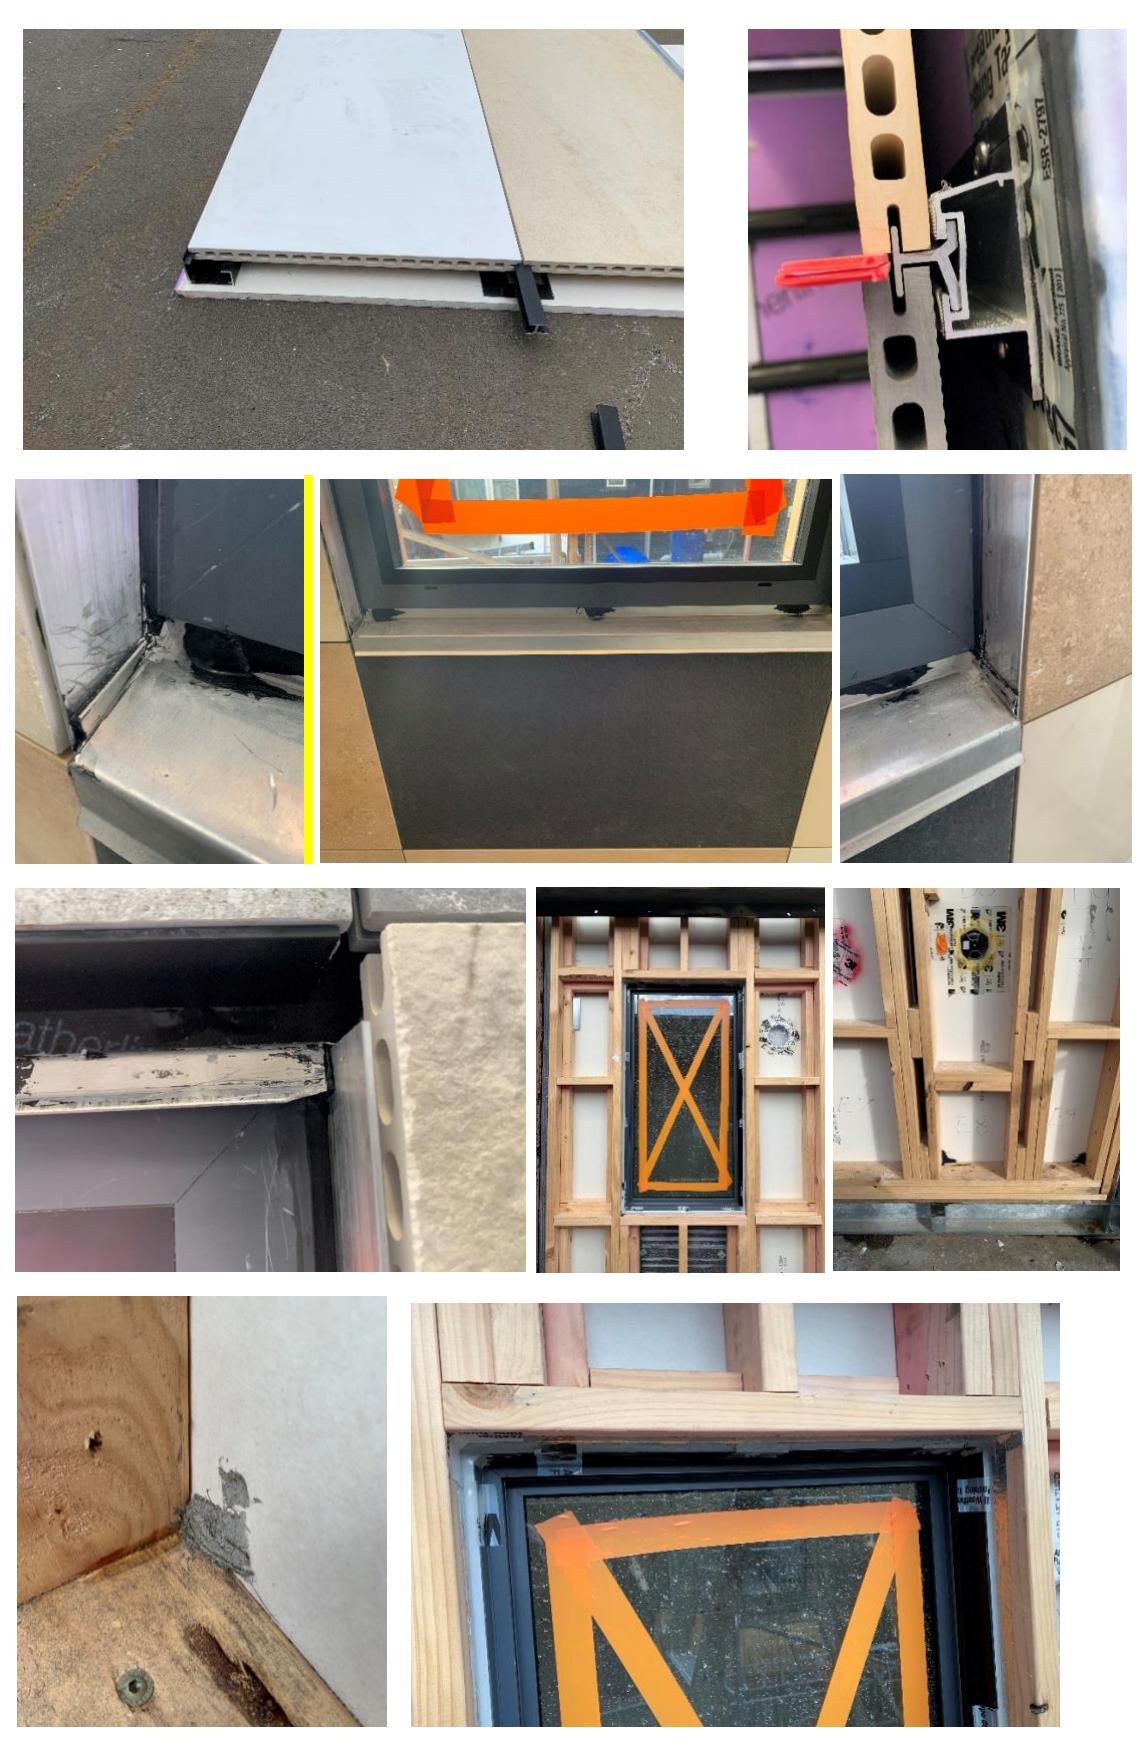
Figure 3: Photos of system during erection and under test

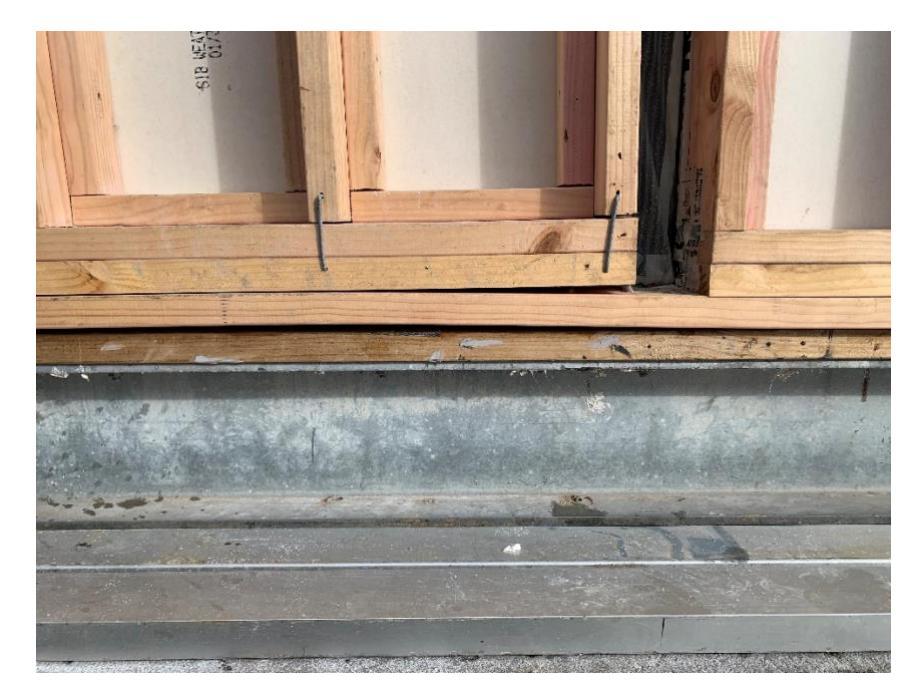
Figure 4: Deformation of the framing following the seismic lateral racking

There was no collapse of the sample during or following this testing, however the racking did result in some disturbance to the attachment of the structural framing to the booth.

There was no collapse of the sample during or following this testing, however there was considerable damage to the connections of the structural system at the bottom plate.
